My Icom 7000's main tuning knob stopped working. Everything else in the radio worked just fine, so I started looking for the tuning culprit. First, I tried the microphone. It was able to change the frequency and all the other mic functions were working fine as well. I tried using a remote control program, Ham Radio Deluxe, and it worked great, changing frequencies as it should. I even tried disconnecting everything except the power-supply and doing a full reset. The tuning knob still did not function.

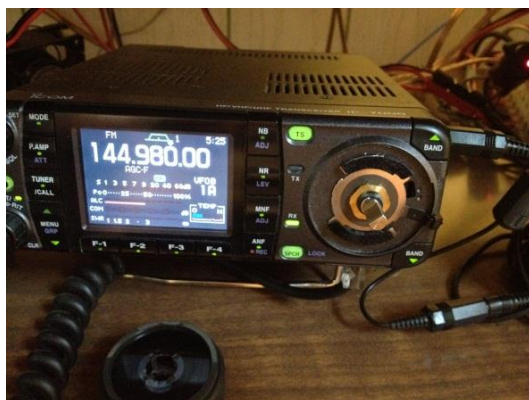
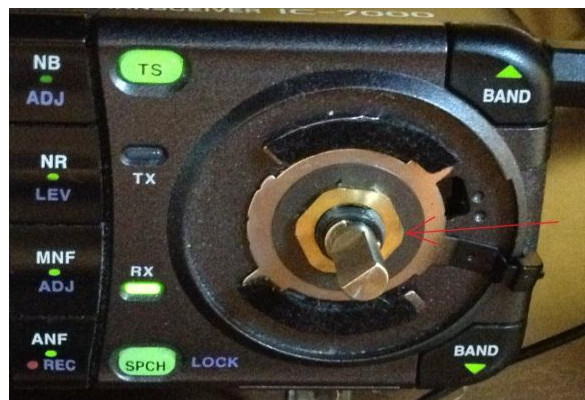
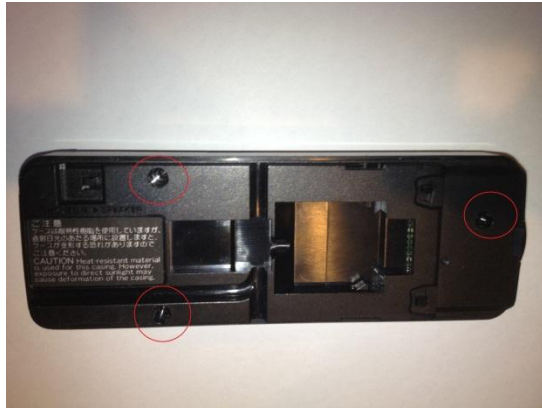
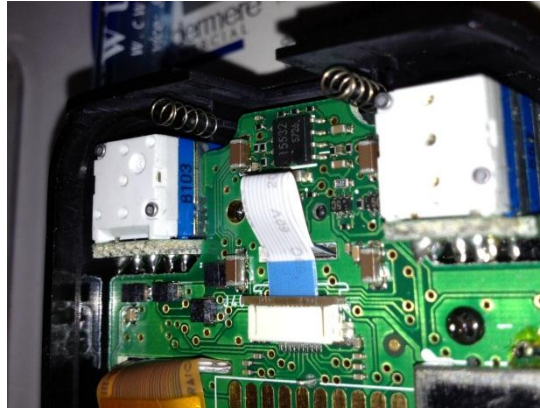
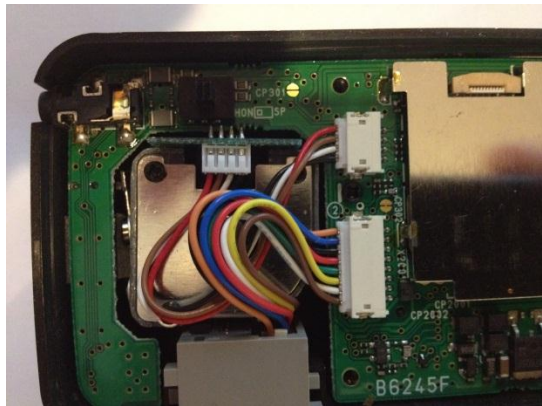
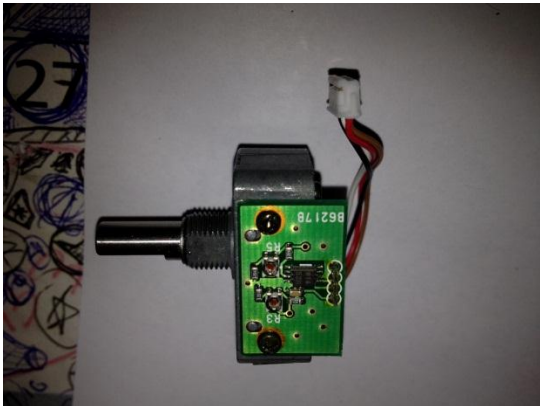
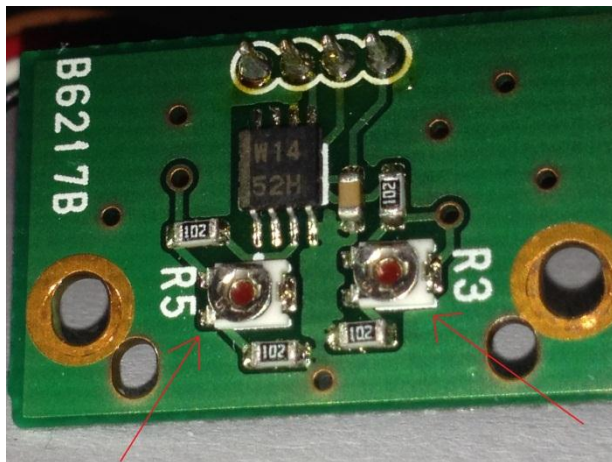
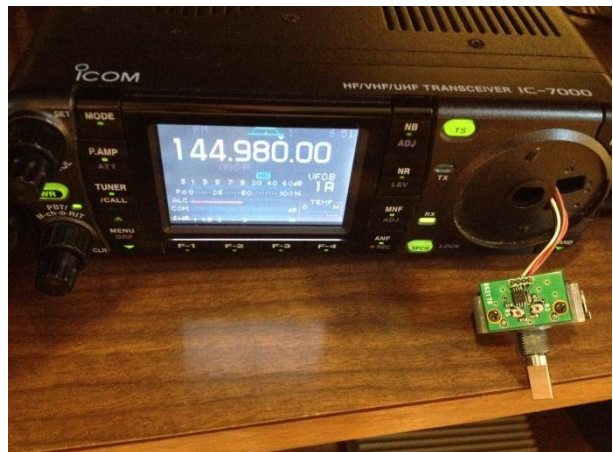
After looking on the web, and downloading the service manual, I started reading and decided the problem was in the encoder. I did not find anything obvious in the service manual about adjusting or calibrating it, but I figured that since these rigs like to run a bit hot, perhaps some values have changed over time and tossed the encoder range out of calibration.

I talked to a couple of ham friends that have experience working on radios like this, and they suggested I try recalibrating the encoder. I was told the encoder must be rotating while tuning is performed. It would have to be removed from the control head to have access to the adjustment potentiometers, R3 & R5. I don't suggest anyone else try this, but this is what I did to fix it.

Making sure the power-supply was off; I started by pulling off the tuning knob. I removed and opened the control head. There are 3 screws on the back and one nut on the front. Being careful not to lose the 2 tiny springs under the control head release button, I carefully removed the encoder. Then I fed the encoder plug back through the tuning knob hole from the front and plugged it back in (see the photo). Then I reassembled the control head, put it back on the radio and put the knob back on the exposed encoder.

I held the encoder unit by its sides and was ready to make the adjustment. I powered the radio back on and had an assistant continuously rotate the dial clockwise. Using an inexpensive non-metallic tuning tool, I carefully adjusted R3 and R5 until the frequencies started changing. I stopped adjusting when it changed up and down correctly. I tested it by tuning in both directions with the tuning knob and saw that it was tracking as it should. At this point it was easy to reassemble the control head. Done!
